Installation instruction FAG 201050

Inspecting the protective ring behind the wheel hub

Manufacturer: Mercedes-Benz

Models: Actros MP2 / MP3
Atego / Atego 2 / Atego 3
Axor 2

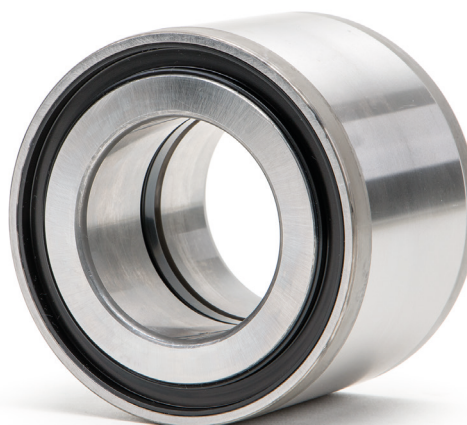
Fig 1: FAG Wheel Bearing 201050

For the specified vehicles, the wheel bearing on the front axle is only available as a complete unit from the vehicle manufacturer (wheel hub with integrated wheel bearing).

However, as it is only the wheel bearing that is faulty in most cases of damage, it is only the wheel bearing that actually needs to be replaced. The wheel hub can be used again.

Schaeffler Automotive Aftermarket is therefore offering a wheel bearing kit under part number 201050.

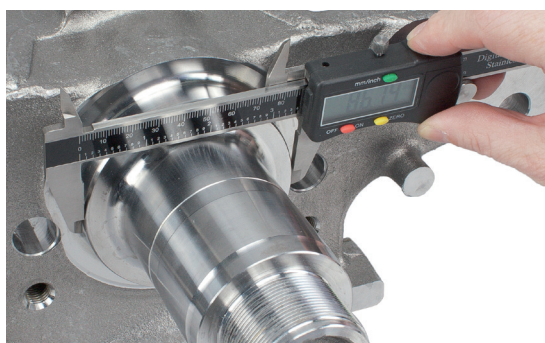
Fig. 2: In order to determine which of the three protective rings will fit, the diameter of the seal seat must be measured

If, while performing the repair, the protective ring behind the wheel hub is found to be defective, it must be replaced. It can be ordered only from the manufacturer of the vehicle.

For correct part selection, note that there are three different variants: In order to identify the appropriate protective ring, the diameter of the seal seat must be measured (Fig. 2).

Diameter measured	Protective ring required
86,70 to 86,85 mm	Protective ring with no coloured marking
86,85 to 87,05 mm	Protective ring with red marking
87,05 to 87,30 mm	Protective ring with white marking
